REPORT DOCUMENTATION PAGE		READ INSTRUCTIONS BEFORE COMPLETING FORM
1. REPORT NUMBER	2. GOVT ACCESSION NO.	3. RECIPIENT'S CATALOG NUMBER
	AD-A108	172
4. TITLE (and Subtitle) National Program of Inspection of Non-Federal Dams Tennessee. Marys Creek Dam No. 8 (Inventory Number TN 15727) near Cross Roads, Tennessee, Shelby County, TN, Wolf River Basin		5. TYPE OF REPORT & PERIOD COVERED Phase 1 Investigation Report

MARY'S CREEK WATERSHED DAM NO. 8
SHELBY COUNTY
MARCH 27, 1981

PHASE I INSPECTION REPORT
NATIONAL DAM SAFETY PROGRAM
TENNESSEE

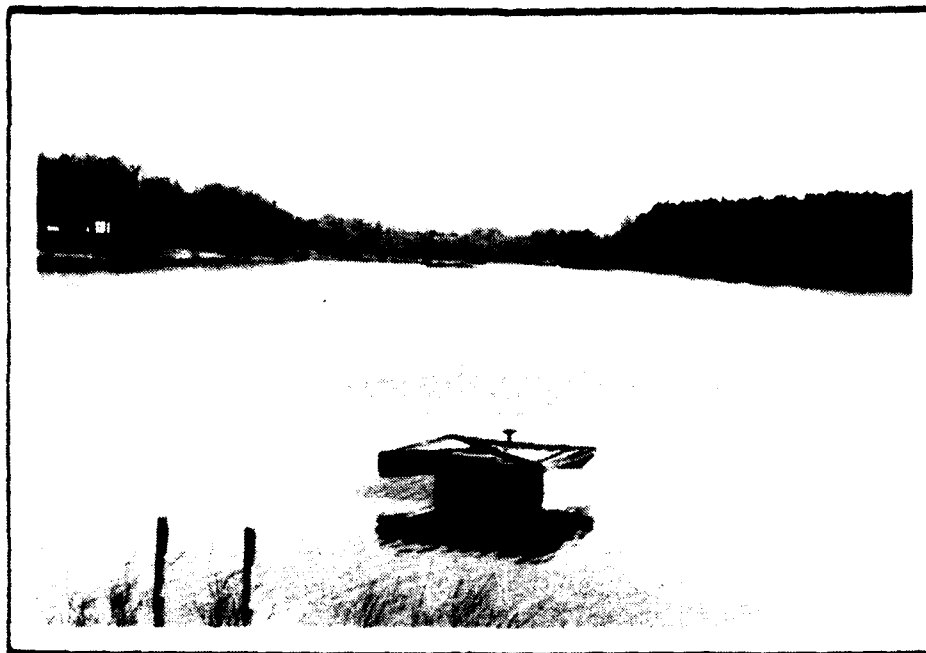
PHOTO NO. 7

- 3.1.2 Service Spillway and Drawdown - The spillway riser appears to be in good condition as viewed from the dam. There appears to be no broken or lost timbers from the anti-vortex baffle or floor cap (see photo no. 7). The spillway outlet is submerged in the plunge pool and was inaccessible for inspection (see photo nos. 13 and 14).

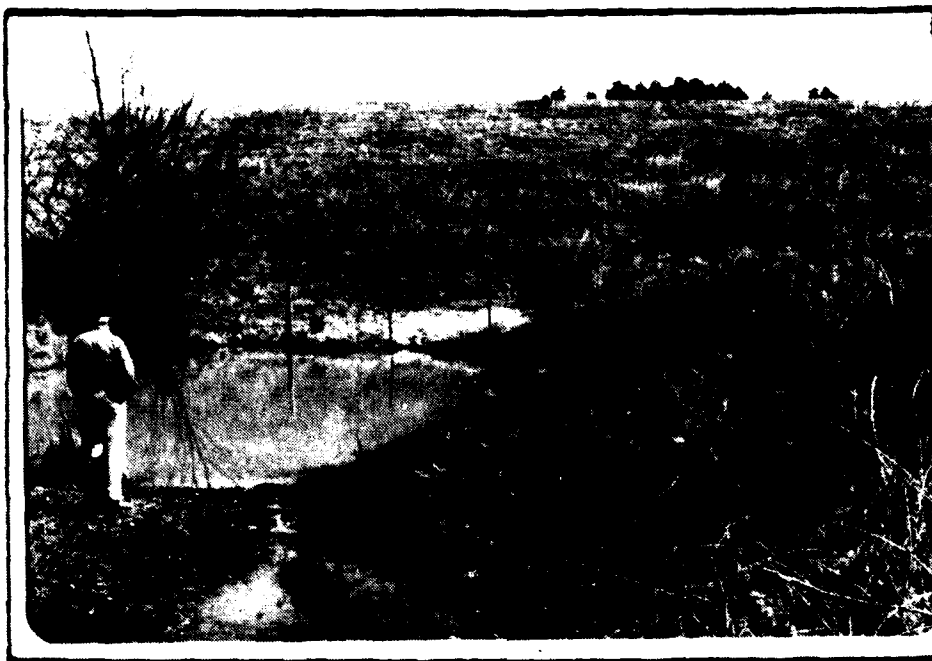
PHOTO NO.13

According to the owner, the drawdown leaked extensively for several years after construction. The valve was considered to be poorly designed and its use was discontinued by the SCS soon afterwards. To remedy the leakage problem, clay was dumped at the inlet. A leakage flow of only a few gallons per minute was observed at the outlet during the inspection (see photo no. 13).

- Photo No. 13 - Stilling basin from downstream.
- Photo No. 14 - Stilling basin.
- Photo Nos. 15 & 16 - Pooled water in downstream section of drainage ditch shown in Photo No. 8.

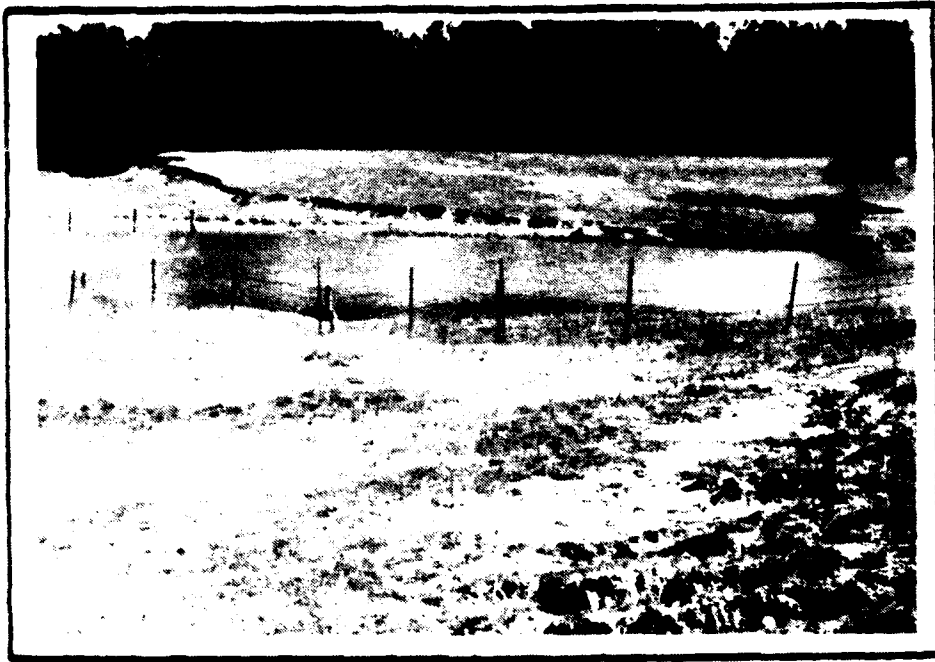
PHOTO NO .17

- Photo No. 17 - Entrance channel of emergency spillway.
- Photo No. 18 - Exit channel of spillway.
